An Introduction to The Retro-Commissioning Process For Existing Buildings

By: Robert L. (Bob) Towell, P.E., LEED AP, QCxP
and Robert Haskell, EIT

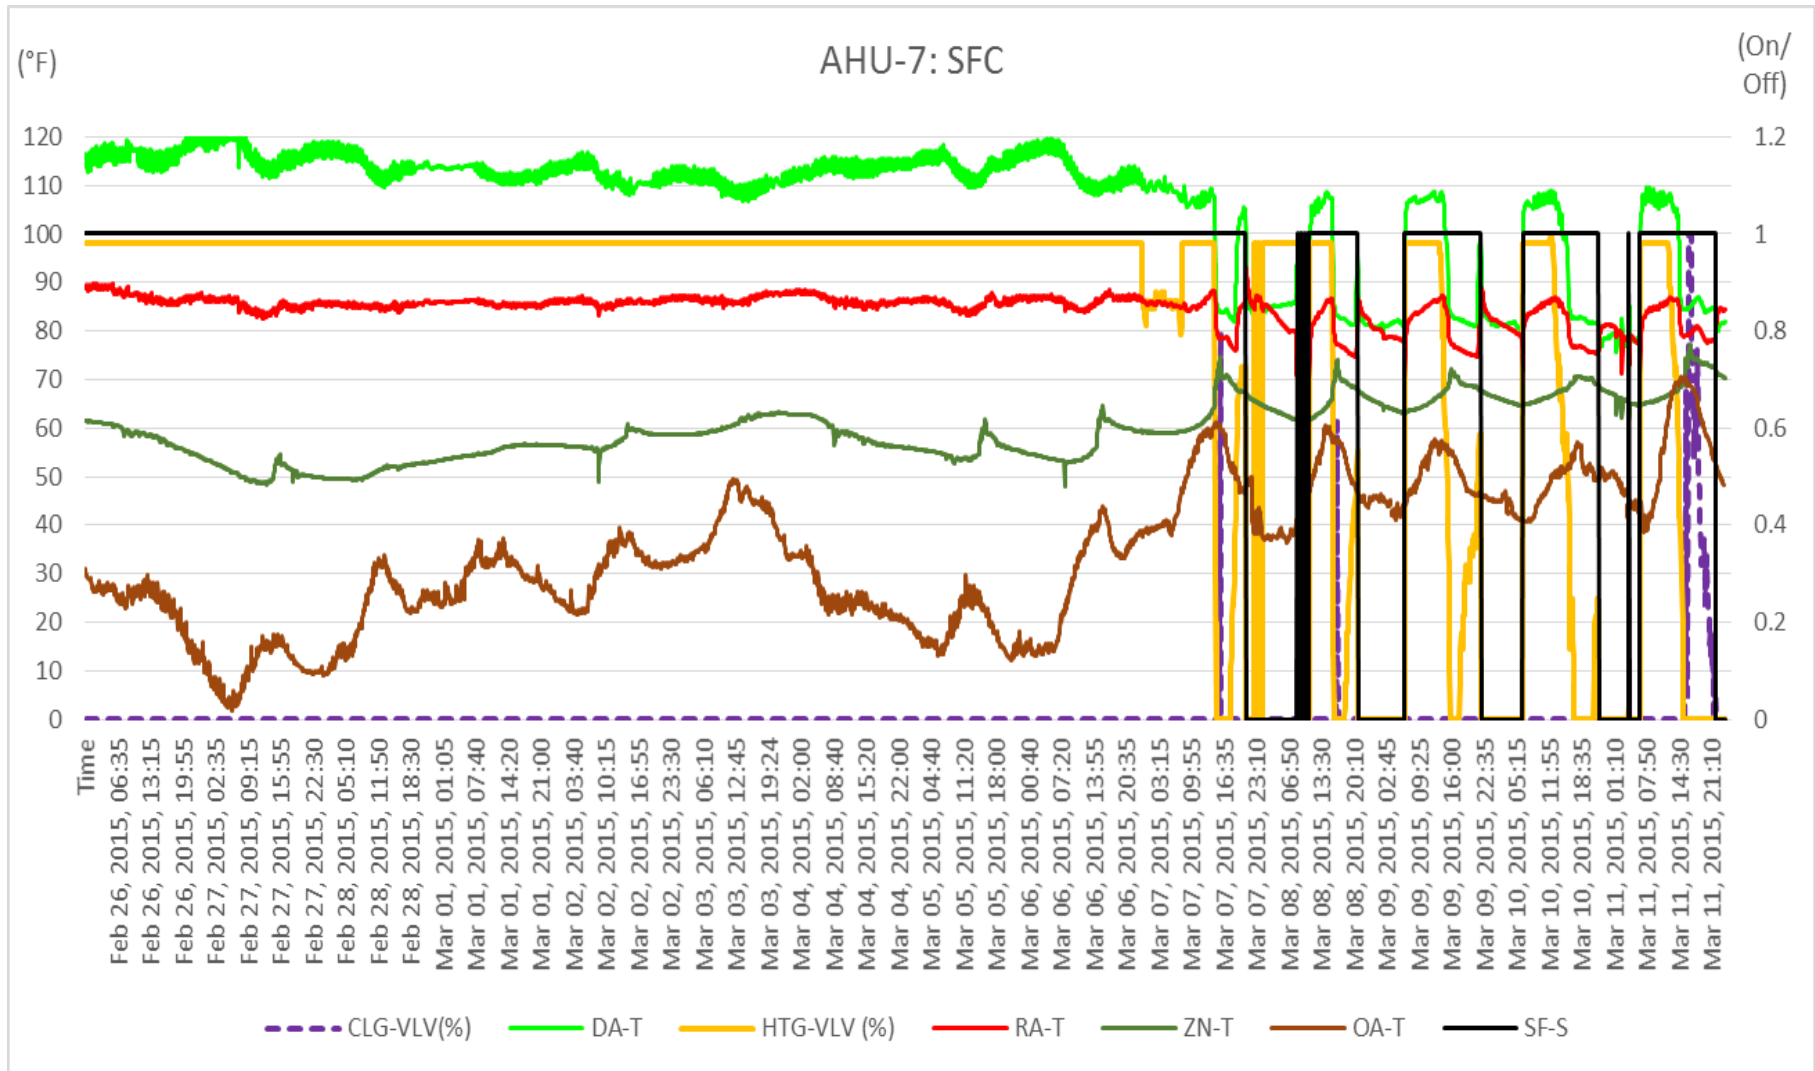
Trend Log Reports

- **Trend Data:** In addition to data loggers, the BAS can be very effectively used to monitor system performance over a period of time, but you have to be careful to avoid overloading control system memory in some cases. Also very useful during verification, plus it works 24 hours per day.

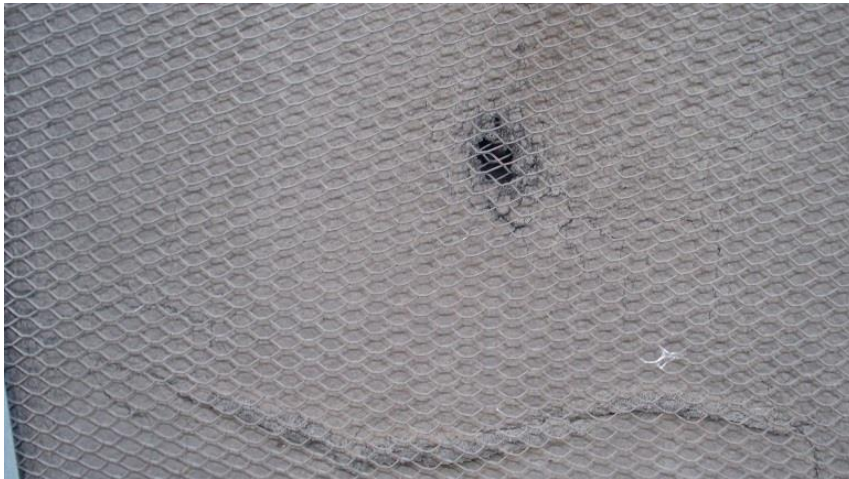
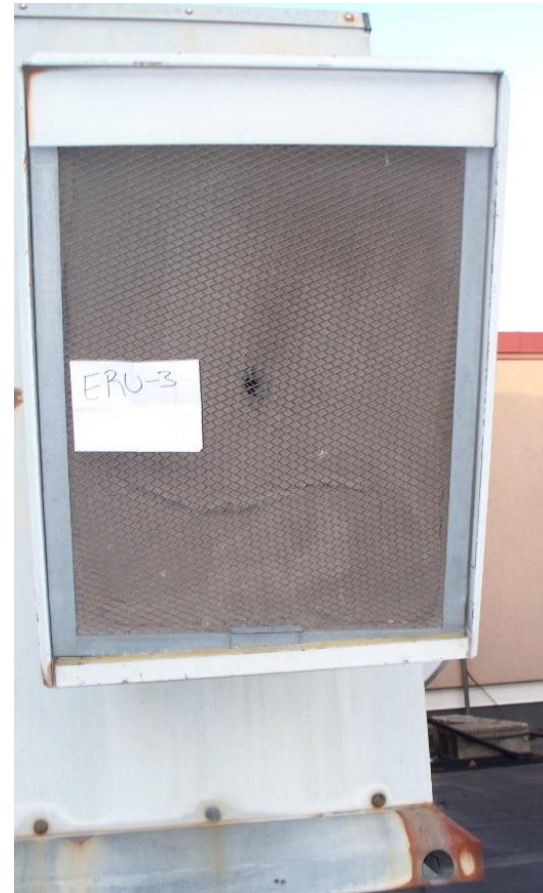
Energy Recovery Unit

- Responsible for ventilation air
- Flow imbalance revealed by functional testing & data logging

- Improperly/ineffectively operating ERUs resulted in space comfort issues
- ERUs were disabled during extreme temperatures
- **ISSUE:** Disabling ERUs eliminated ventilation air for portions of facility!
- Corrective Action:
- Evaluation and correction of ERU operation to meet facility needs
- Control upgrade to the units tasked with conditioning the spaces with comfort issues

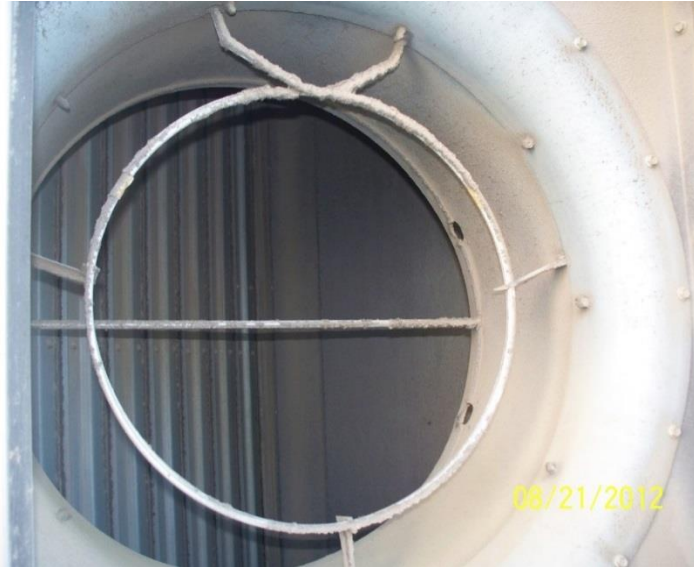
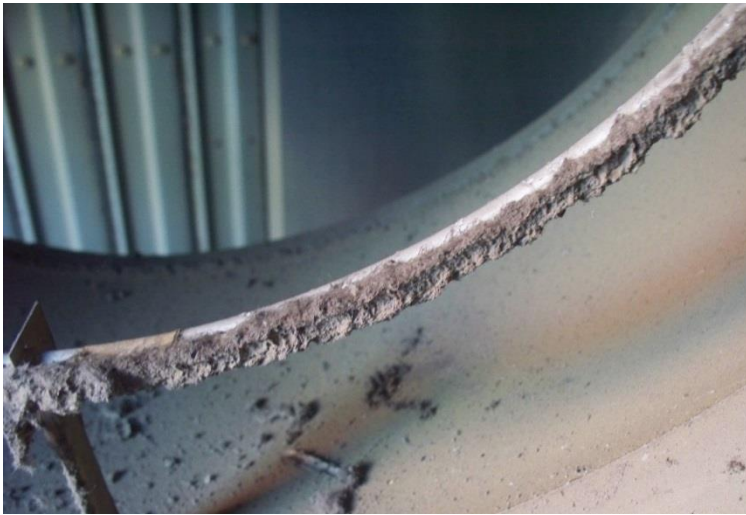
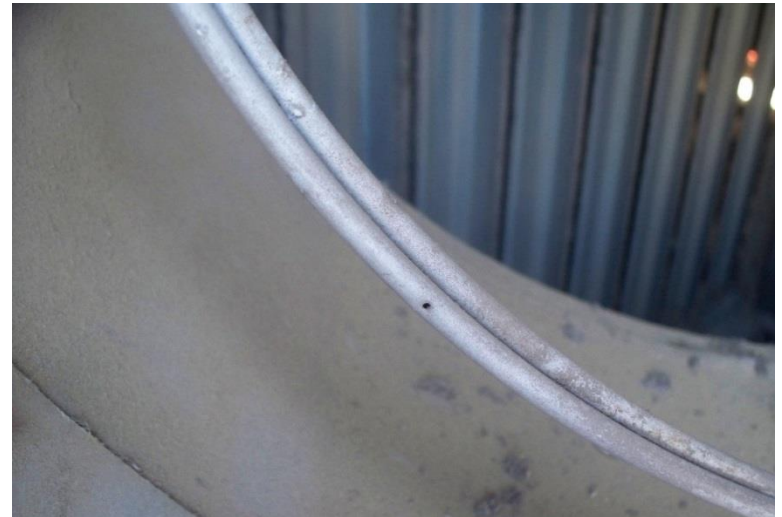
Dirty Air Flow Station

- Inaccurate readings
- Improved unit operation & efficiency after corrected

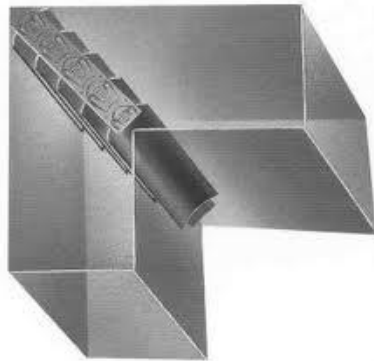
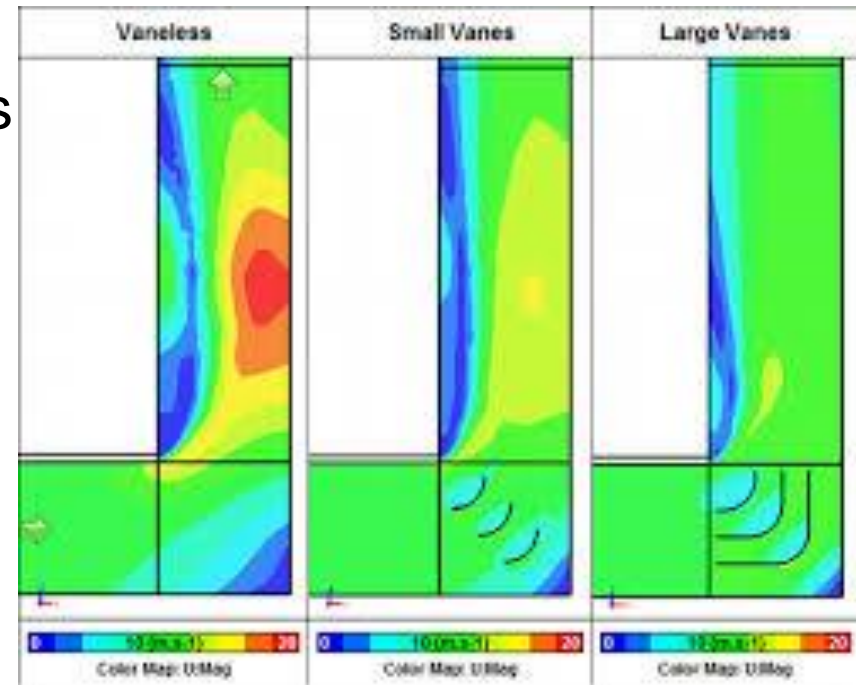
Missing Turning Vanes

- Observed inconsistent installation during site walkthrough
- Vanes being installed 'per the plans'
- Plans found to not call out every instance where vanes were applicable
- 5x higher pressure drop w/o vanes
- Turning vanes were installed in all 90° elbows

CORRECT VANE ALIGNMENT CREATES
UNIFORMITY OF AIRFLOW; RESULTS IN
REDUCED PRESSURE DROP

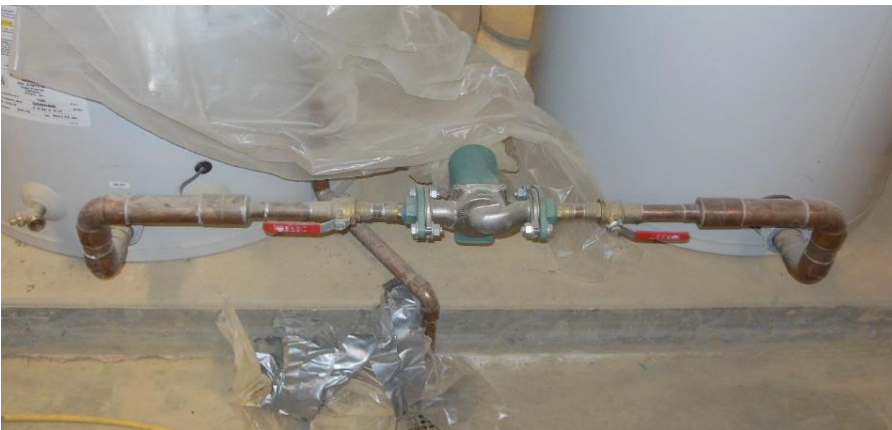
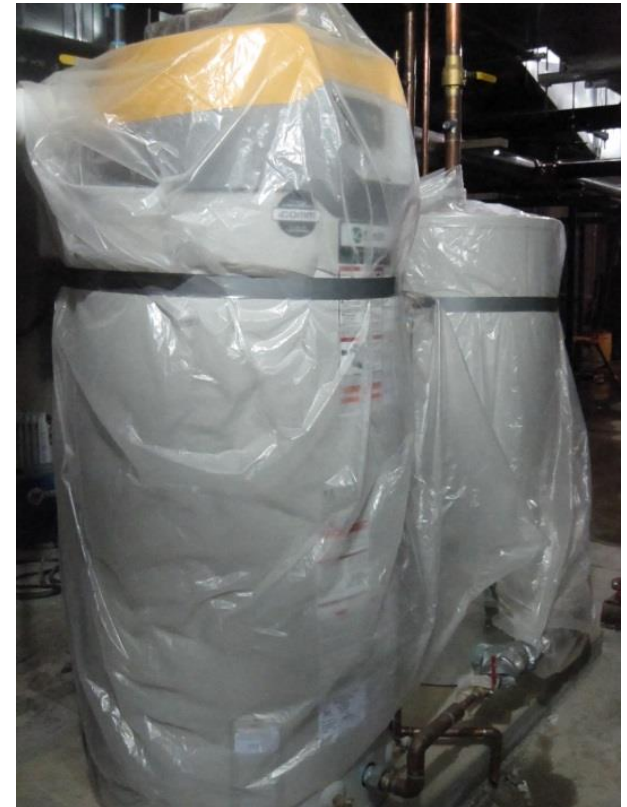
Undersized Circulation Pump

- 2 GPM pump installed to circulate water between storage tank and water heater
- Heater recovery capacity was 460 GPH
- Pump capacity insufficient to permit heater to operate at full capacity as installed
